## VISUAL INSPECTION REPORT (API-570 – Process Piping)

<b>Client:</b> <u>  DTS Client  </u> <b>Location:</b> <u>  Somewhere USA  </u>
	<b>Circuit Number:</b> <u>  GL-P-03-03  </u> <b>Date Built:</b> <u>  1981  </u>
	<b>Circuit/Process Name:</b> <u>  Gas Gathering sub-header &amp; header at well room #3.  </u>
	<b>P&amp;ID No.:</b> <u>  558-F-101  </u> <b>Service:</b> <u>  Gas Gathering  </u>
	<b>Inspector Name:</b> <u>  API Visual Insp.  </u> <b>API 570 #</b> <u>  18  </u> <b>Date:</b> <u>  11/25/03  </u>

**Circuit No.:** GL-P-03-03

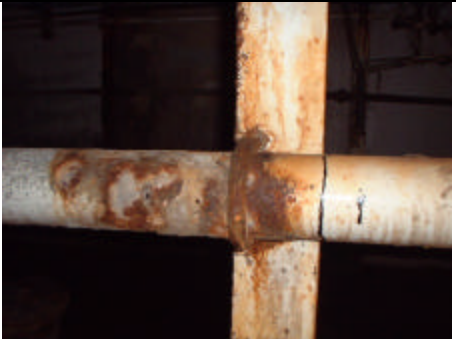
The piping does not have single points of contact between the piping and the support beams. Single points of contact help prevent moisture from sitting against the piping surface and promoting corrosion. At this time moderate to heavy corrosion and scale was noted at the contact points between the piping and supports.

Throughout the circuit, the U-bolts were found to be near failure due to corrosion.

* Narrative Photo Attachment Page *			
Circuit No. GL-P-03-03		Date: 11/25/03	
Heavy corrosion on U-Bolts and supports

<i>*Recommended Items for Repair*</i>	
Item	Recommendations
1	Consideration should be given to removing corrosion from supports and installing single points of contact to eliminate the possibility of future corrosion between the piping and supports.
2	Replace corroded, broken or missing U-bolts.
3	Consideration should be given to scheduling the removal of any existing external corrosion for the purpose of measurements and / or repairs at such a time that any through-wall corrosion would not result in a disruption of platform operations.
4	The damaged coating should be thoroughly cleaned to an industry standard acceptable to engineering and new coating applied to arrest the present corrosion and prevent further corrosion.

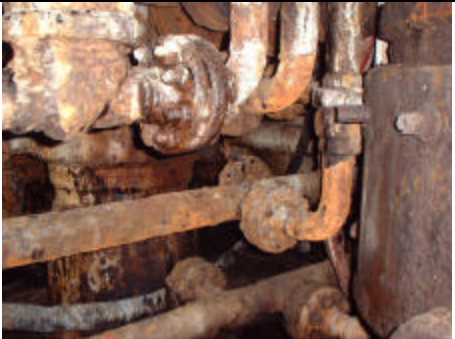
Throughout this circuit the coating on the header is mostly intact with few small corrosion blisters throughout and significant corrosion at the point of contact with the supports. Most of the coating on the sub-headers has failed and there is heavy corrosion and scale throughout the sub-headers. The damaged coating is not affecting the operational conditions of the piping at this time. All areas of blistered or damaged coating, rust and scale should be thoroughly cleaned to an industry standard acceptable to engineering and new coating applied to arrest the present corrosion and prevent further corrosion.

Complete coating failure and heavy corrosion on sub-headers

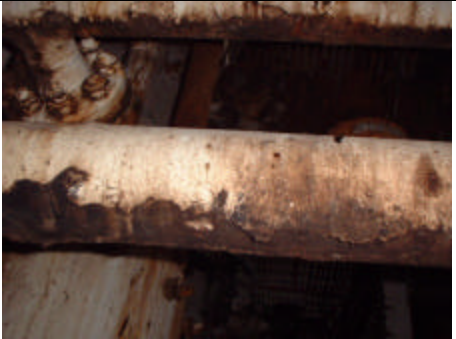
Heavy corrosion and scale along bottom of headers

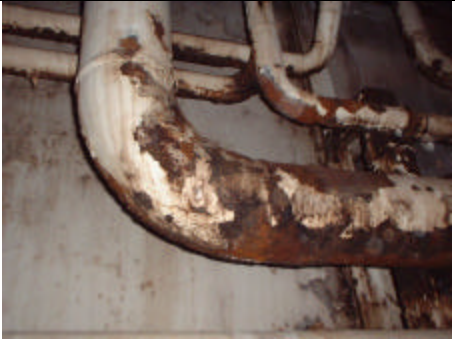
Coating failure with heavy corrosion and scale on header to 6" valves on south wall
