EXTERNAL VISUAL INSPECTION REPORT (API-653 – Atmospheric Storage Tanks)

Client: <u>DTS Client</u>	Location: <u>Somewhere USA</u>
	Storage Tank Number: <u>Tk-1902</u>	Date Built: <u>1972</u>
	Storage Tank Name: <u>Oxidizer Tank</u>	
	P&ID No.: <u>F-9761-6</u>	Service: <u>Process Slurry</u>
	Inspector Name: <u>API Certified Insp</u>	API 653 # <u>16</u> Date: <u>12/24/2003</u>

Storage Tank No.: Tk-1902

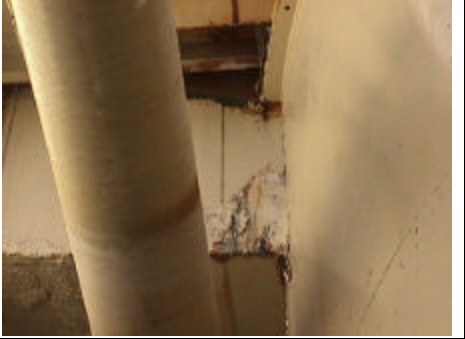
Leaking patch on flume duct.

<i>*Recommended Items for Repair*</i>	
Item	Recommendations
1	Repair flume leak and re-coat.
2	Remove corrosion from shell bottom and bottom extension below flume leak.
3	Evaluate wall loss, repair if necessary and re-coat.
4	Remove existing coating, and corrosion from clean-out door and re-coat.
5	Remove corrosion from top edge of shell, flume box and bottom extension and re-coat.
6	Install missing flange bolt.

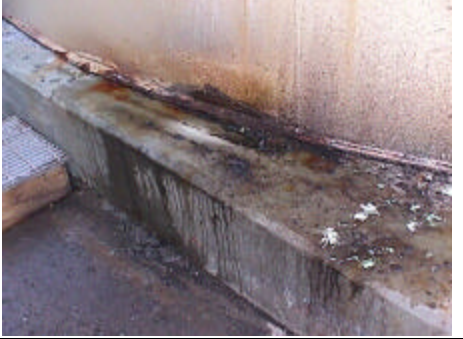
Corrosion on shell and bottom extension below flume duct leak.

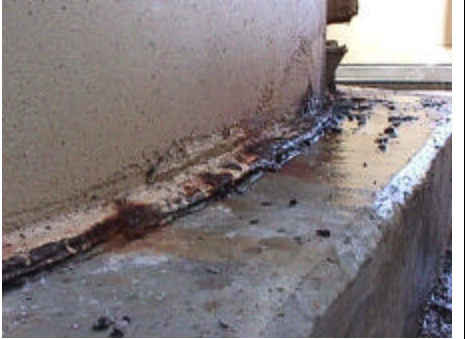
Bottom extension and shell corrosion below flume duct leak.

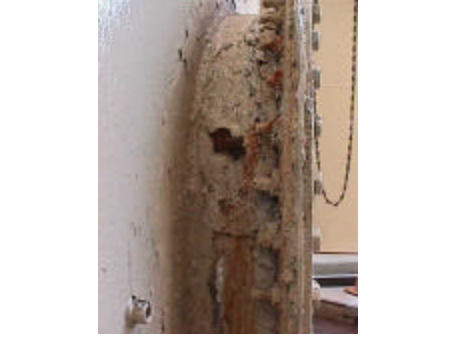
Corrosion under new coating on clean-out door.

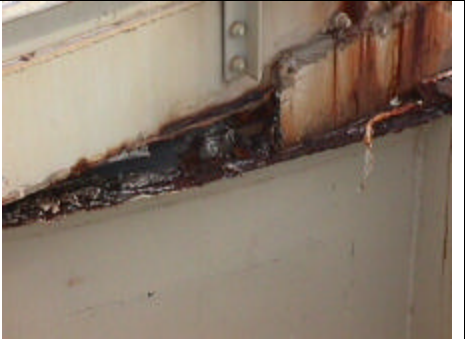
Corrosion on top of tank shell.

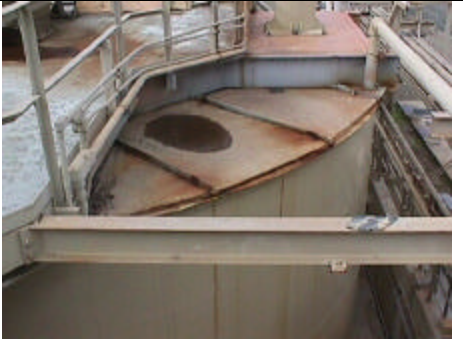
Corrosion along top of tank.

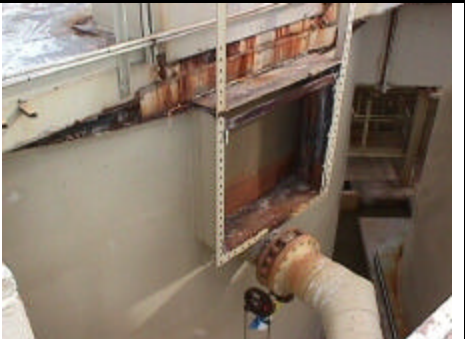
Corrosion on flume box.
