INTERNAL VISUAL INSPECTION REPORT (API-653 – Atmospheric Storage Tanks)

Client: DTS Client **Location:** Somewhere USA
Tank Number: TK-1903 **Date Built:** _____
Tank Name: 3,000 bbl. Oxidizer Tank
P&ID No.: F-9761-6 **Service:** Process Slurry
Inspector Name: API Certified Insp **API 653 #** 16 **Date:** 11/08/03

TK-1903

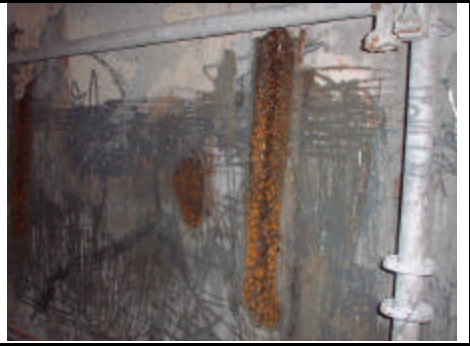
The internal coating has numerous areas of damaged and peeling coating. The coating on the floor, bottom 24" of the shell, and below the chute to TK-1902 were all sandblasted and new coating was applied. Rust and peeling coating were noted further up the tank shell and engineering reported they might consider recoating the entire tank internally after evaluating this coating application at the next inspection interval.

Area of rust on shell

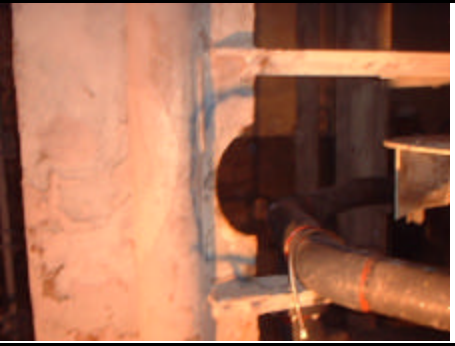
The roof support columns appear to be in satisfactory condition. The swirl baffles on the columns next to the agitator have experienced significant wear and corrosion (see photos). The swirl baffles were sand blasted and coated to help prevent further corrosion. If the coating is damaged and corrosion continues at the next inspection, consideration may be given to replacing sections of the swirl baffles.

Swirl baffle with corrosion at agitator

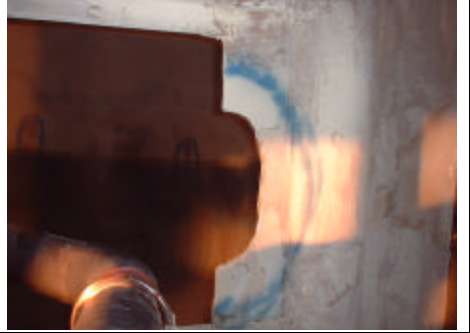
Swirl baffle with corrosion at agitator

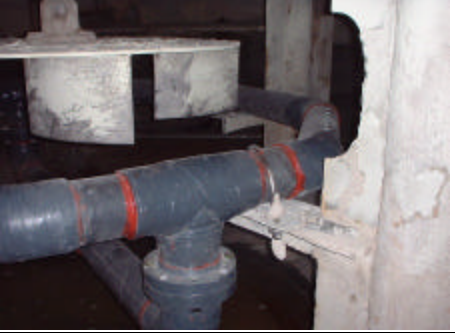
Swirl baffle with corrosion at agitator

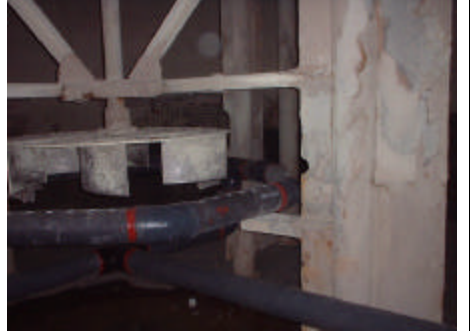
Swirl baffle with corrosion at agitator
